**Assessment of Flooding Hazard  
along the Highway 101 corridor near Windsor, NS using LIDAR**

Final Report submitted to the  
Nova Scotia Department of Transportation and Infrastructure Renewal (NSTIR)

Prepared by  
Dr. Danika van Proosdij  
Department of Geography

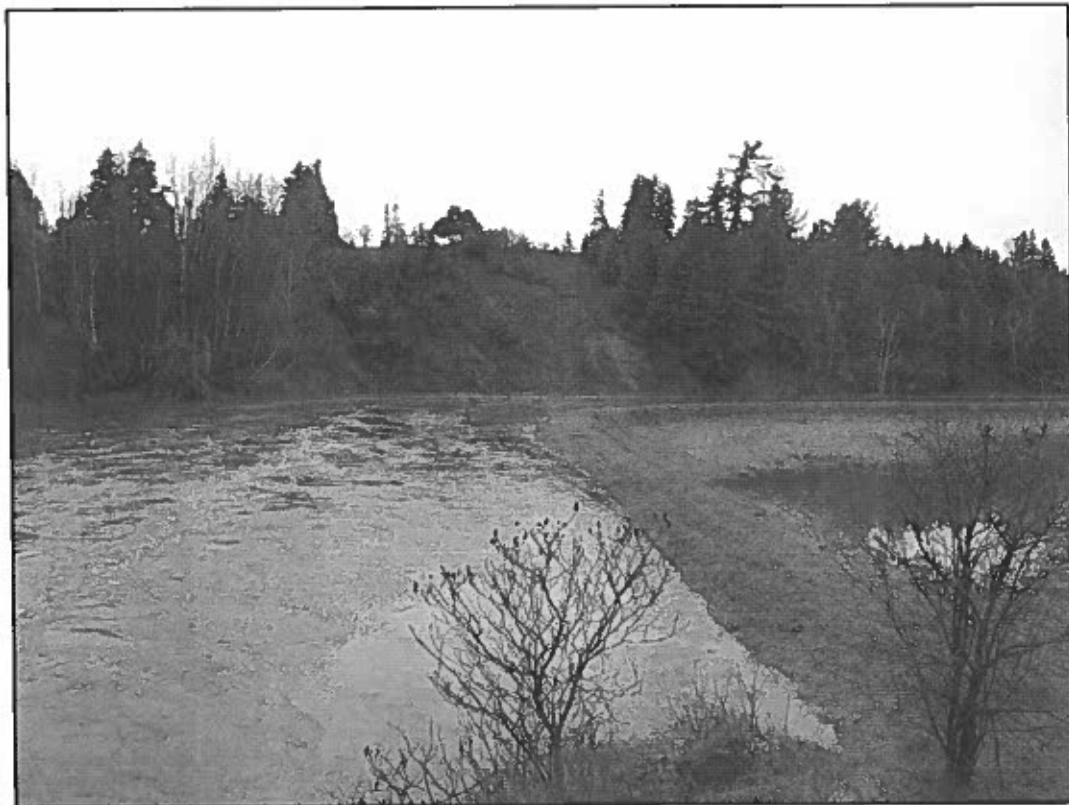
*Figure 1: Bankfull conditions along the St. Croix river near Wentworth Rd.*

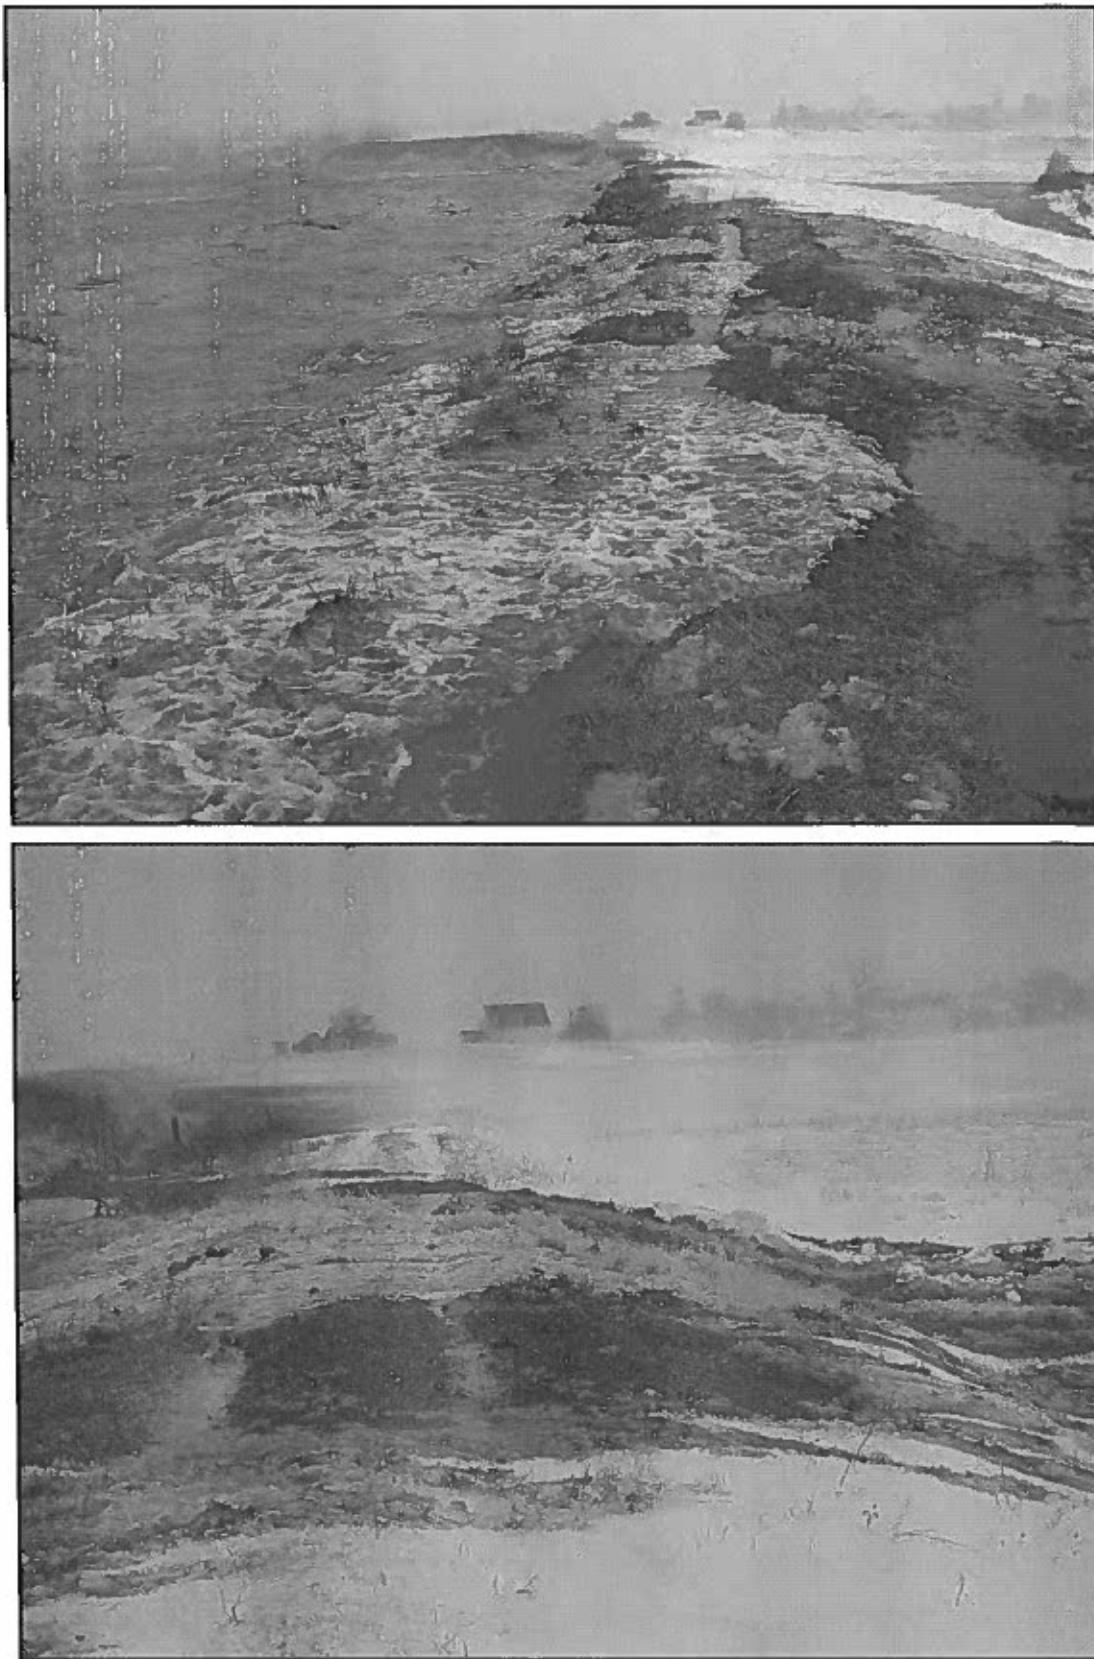
*Figure 3: Storm impacts on Feb 1, 2006 at the Avonport Dyke. a) storm waves battering marsh; b) storm surge reached upper limits of dyke and dyke overtopped. Photo by T. Hamilton, 2006.*

To date, the highest tides recorded at the causeway tide gate were 8.87 m (29.1 ft) (date unknown) (pers com. K. Carroll, 2007) and 8.6 m CGVD28 (28.2 ft) on January 10, 1997. These tide levels reflect the Saros cycle or the 4.5 yr cycle mentioned previously. Examining the digital record between April 2002 and September, 2006, a total of 121 tides exceeded the HHWLT elevation (7.57 m CGVD28). Eleven of these dates were greater than 8.0 m (Table 2) with the highest recorded tide on February 1, 2006 (8.2 m) which overtopped dykes in many areas (Figure 3).

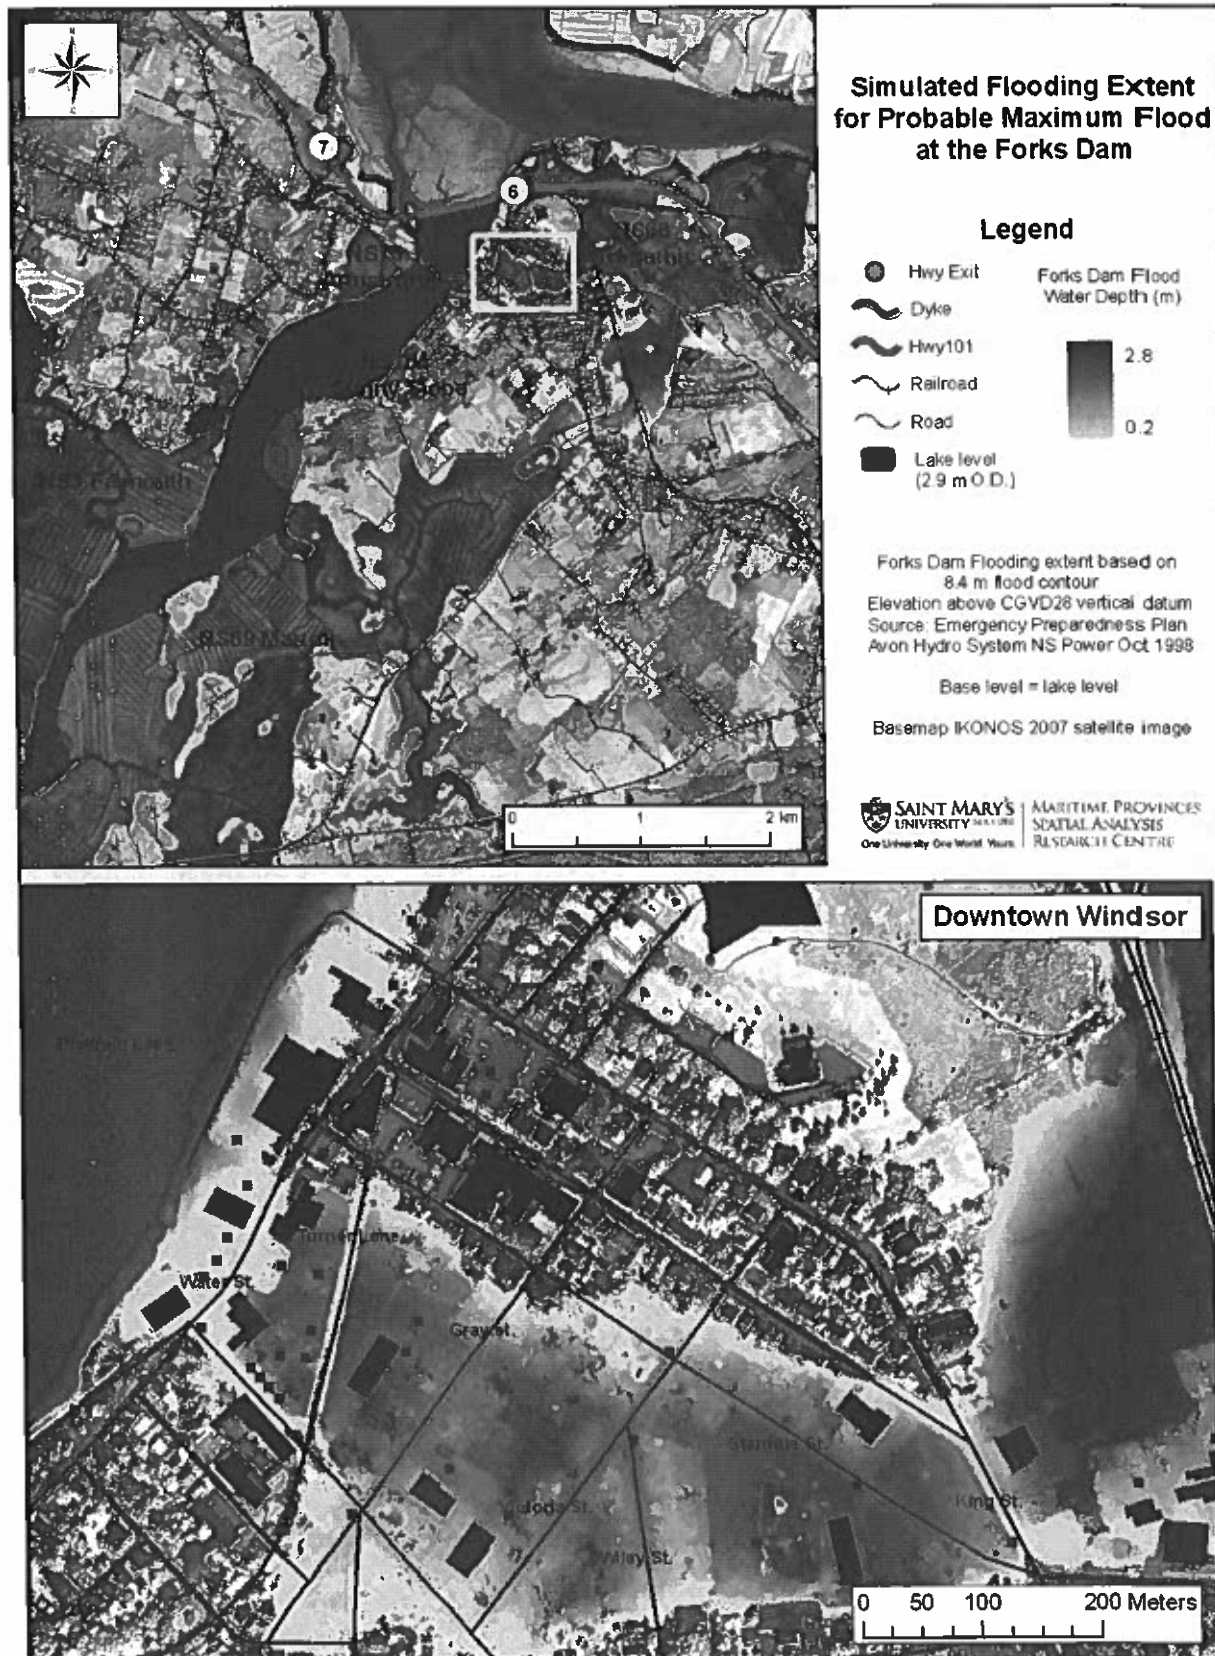
Figure 10: Simulated flood event for a probable maximum flood at the Forks Dam depicted damage to the Town of Windsor.

Figures 9 and 10 illustrate the flooding extent and depth associated with probable maximum floods at the Falls Lake and Forks Dams. In both cases, the majority of marsh bodies upstream of the causeway would be flooded, including NS3 Falmouth, NS69 Martock, NS104 Sunny Slope and NS75 Armstrong. Most of this is due to the fact that dykes within these areas have long been removed after the causeway was constructed or not maintained. In the case of the Falls lake flood, the levels of Pisiquid lake would rise less than 0.5 m above base level (2.9 m CGVD28) and cause only minor localized flooding along the waterfront. A Forks Dam flood however has the potential to cause significant damage as the elevation of neither Water St. nor Turner Lane are sufficiently high to block the flow of water (Figure 10). Water would flow past King St. and join the larger Tregothic marshbody behind.

Much of the flooding hazard upstream of the causeway originates from building on or near former agricultural marshland. Figure 10 depicts the marsh bodies and flood zones upstream of the causeway. The area of flooding is extensive and surrounds the town of Windsor. If the causeway were to be removed, there would be significant risk to the town and associated infrastructure and considerable cost in rebuilding and/or repairing the dykes. One of the original reasons for constructing the causeway in the first place was to decrease the amount of area that needed to be protected by dykes that require regular, costly maintenance. It should be noted that this assessment of flood hazard to the town of Windsor is preliminary and further in depth studies are required regarding the economic implications and site specific impacts (e.g. built infrastructure and property level) as well as groundtruthing.
